# Basic Characteristics and Cause Analysis of Debris Flow Disaster in Keze 2 # Gully of Jiuzhaigou Earthquake Area

## Abstract

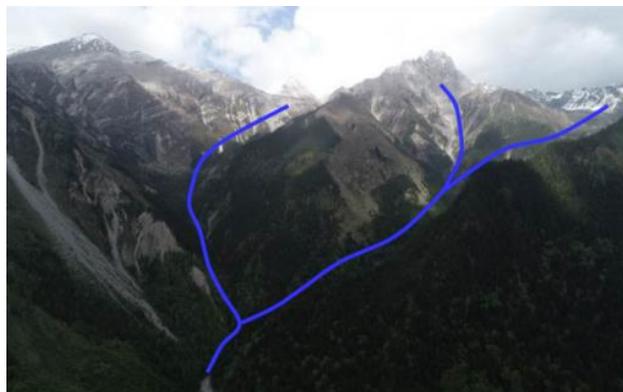
According to the field investigation, combined with the characteristics of topography and channel erosion and deposition, the catchment area of 3100 m~4442 m elevation is clear water collection and debris flow initiation area. The relative height difference is 1342 m, the gully area is about 16.35 km<sup>2</sup>, accounting for 82.2 % of the whole debris flow. The gully length is about 3.76 km, and the average longitudinal slope of the gully is 356.9 ‰. Most of the bedrock in the clear water area is exposed, and the loose accumulation layer is thin, which is formed by cold weathering erosion. It is mainly bedrock slope. There is no sign of large deformation and failure on both sides. There are local accumulation bodies with collapse and instability. On the whole, the source is less. It is the main clear water catchment area of Keze gully, and the hydrodynamic condition for the formation of debris flow. The strong scouring of the downstream gully bed by gully water is beneficial to the initiation of loose solid source along the gully, and the area is dominated by scouring erosion. The valley characteristics in this area are shown in Figs. 4 and 5.

Fig. 4 Upstream aerial photographs of main ditch, 1 # branch ditch clear water area and formation area

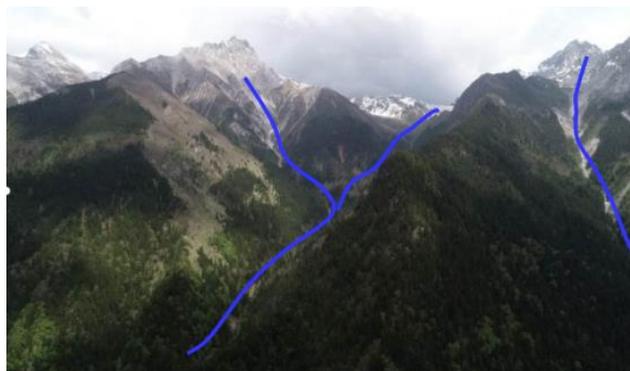
Fig. 5 Upstream aerial photographs of clear water area and formation area of 1 # and 2 # branch ditches

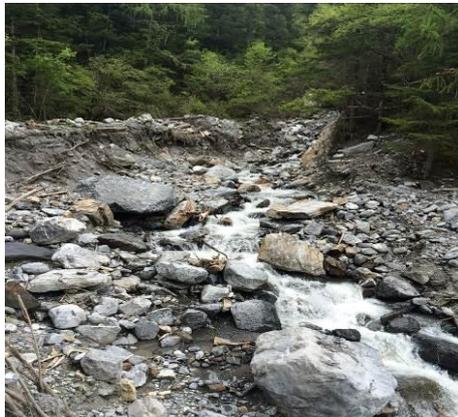
The elevation range of the circulation area is 2640 m–3100 m. The channel length is about 2.54 km, the average longitudinal slope is about 181.1 ‰, and the total area is about 3.37 km<sup>2</sup>. The main channel in provenance area is 'U' type valley, and the local channel is 'V' type valley. The bottom width of the channel varies greatly, and the general width is 10~60 m. The upstream channel in the forming circulation area is narrow, and the general width is 3~5 m. The channel is mainly 'V' type valley, and the local channel is relatively open, and the downstream channel is generally 10~60 m. The channel in the circulation area is straight, the bank slopes on both sides of the valley are steep, and most of the bedrock is exposed. Affected by earthquake, structure and weathering unloading, the bedrock is broken and easy to form a collapse body. The loose material covered in the local section of the bank slope is mainly residual slope and collapsed slope gravel soil, which is generally 3~5 m thick. Under the action of surface runoff, the surface loose rock and soil are taken away locally, which is the main source of fine particle composition in debris flow. The characteristics of erosion and deposition in the circulation area are mainly characterized by erosion and local deposition (see Figs. 6 and 7).

Fig. 6 Forming the upstream of circulation area

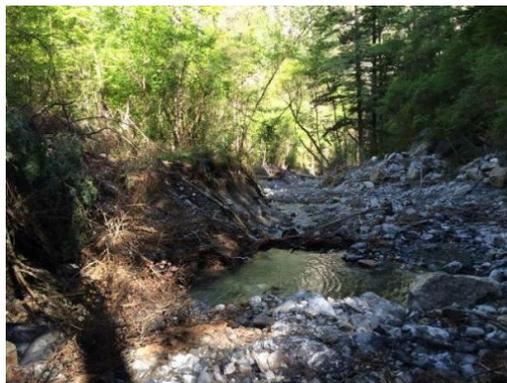
Fig. 7 Middle and lower reaches of flow accumulation area

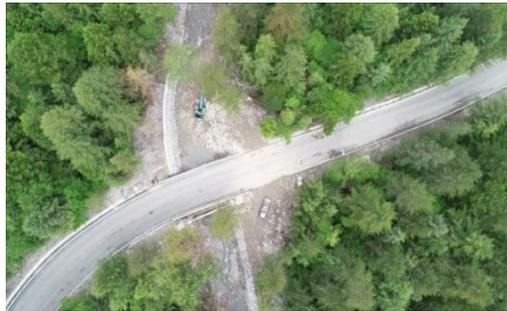
At present, the gully is mainly passed along the right side of the fan, and the front edge of the accumulation area is the highway in the earthquake area (Fig. 8), which is the main area of human activities and is the object of debris flow protection. The drainage ditch is constructed by the water department in the gully mouth section of the accumulation area. The drainage ditch extends from the Kize 2 # gully to the Norilang Falls downstream of Zezhawazhai, about 4.5 km long. The existing drainage ditch meets the road in the earthquake area three times, and passes in the form of bridges and culverts, as shown in Figure 9.

Fig. 8 Aerial Photographs of Trench Threat Objects (Earthquake Area Highways)

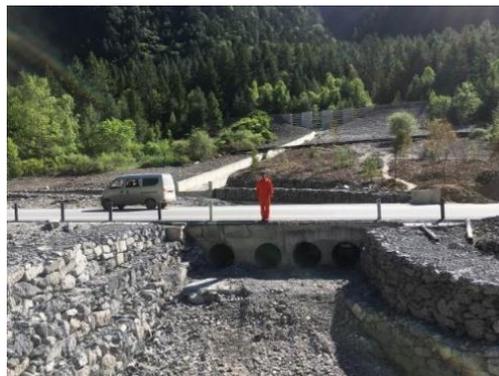
Fig. 9 No. 2 Bridge and Culvert of Drainage Ditch

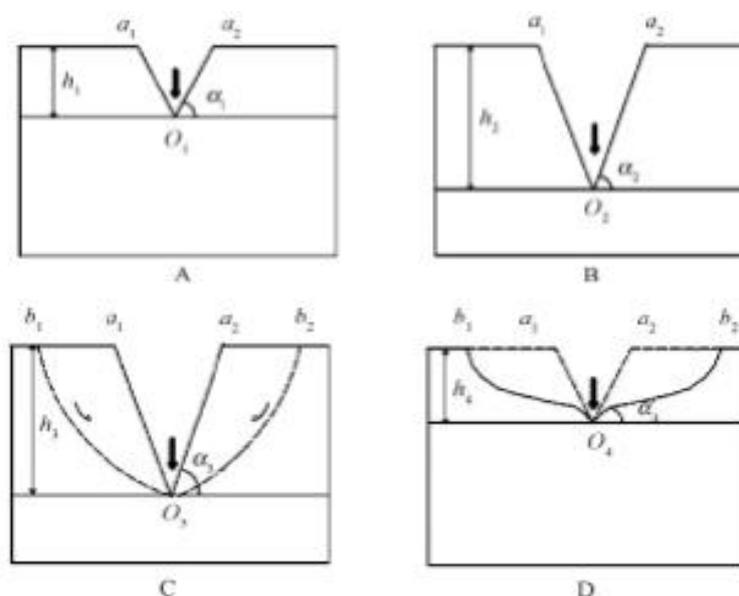
Due to the accumulation of a large number of loose materials in the channel after the '8.8' earthquake, under the action of rainfall, the formation of flood after surface water confluence has a strong downward erosion effect on the loose deposits in the gully bed, and gradually forms deep gully, which provides an effective free surface for the accumulation slope on both sides. Then the tractive collapse of the ditch, the final collapse into debris flow. The start-up process of debris flow source can be roughly divided into four stages: undercutting erosion (A), gully formation (B), collapse and blockage (C), erosion and collapse (D), see figure 10.

Fig. 10 Schematic diagram of provenance start-up mode of debris flow gully under gully erosion and collapse O -gully erosion baseline. a – The width of undercutting gully. b-potential collapse surface. h - Ditch depth.  $\alpha$ -slope angle

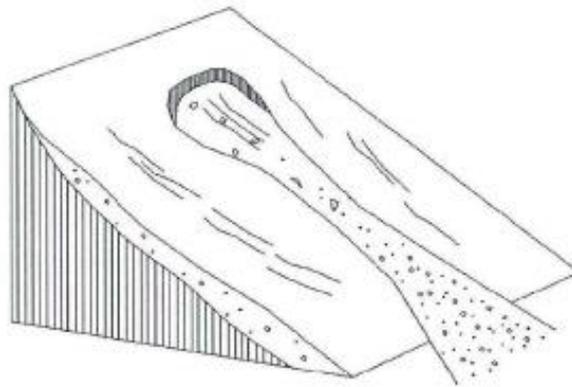
The source of erosion on the slope is residual on the slope, and there is a certain distance from the gully. Most of them will not actively participate in debris flow activities, and the slope of the source point of debris flow activities is relatively large. They mainly participate in debris flow activities after entering the gully along the slope under rainstorm erosion. Some can reach the bottom of the slope or enter the gully, and then be carried away by debris flow. The start-up model can be roughly divided into three processes : rainstorm scouring, handling stops, along the inflow ditch, see figure 11.

Fig. 11 Start-up mode of source reserves of erosion on slope surface
