# Failure Analysis of Elastic Pad Under Railway Track

The elastic pad under the rail of a subway line cracked and shattered. A variety of characterizations were performed on the failed pad, such as: PY-GC/MS, FTIR, EDX, DSC, SEM observation of the surface and fracture, etc. Research shows that: the elastic pad belongs to fatigue cracking, mainly due to squeeze abrasion damage; the failed pad is slightly degraded; there are holes in the pad, which accelerates its fracture.

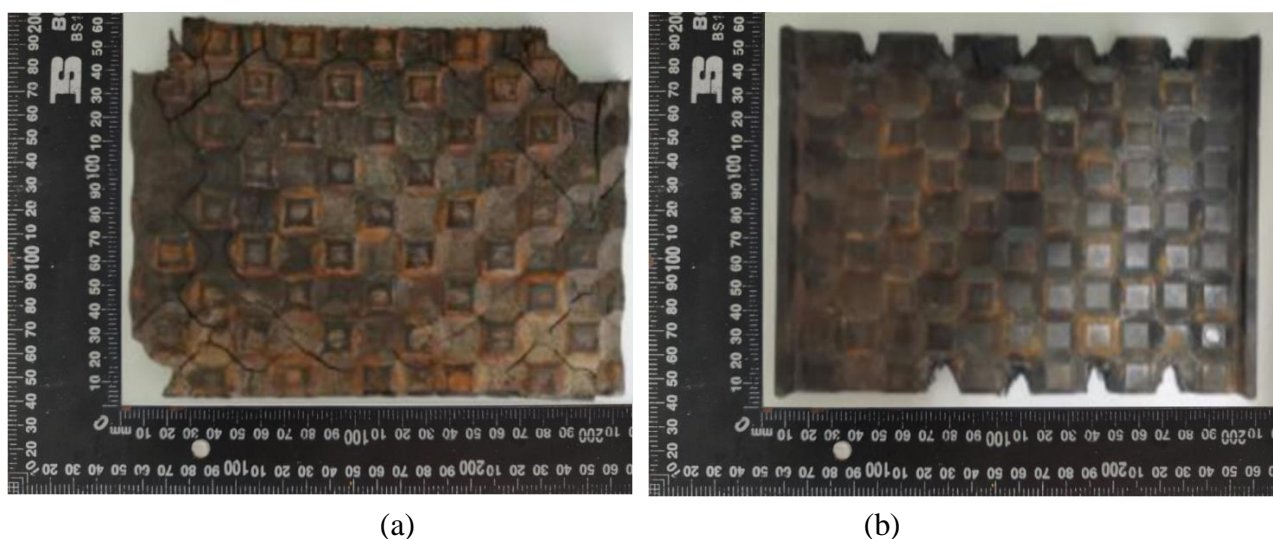
The elastic pads under railway track and the elastic pads under the iron pad made of thermoplastic polyester elastomer (TPEE) used in a subway line were found to be cracked and broken after 4 to 5 years of installation and service, which was far from reaching the designed service life.

Fig. 1 (a) the failed elastic pad, (b) the normal elastic pad

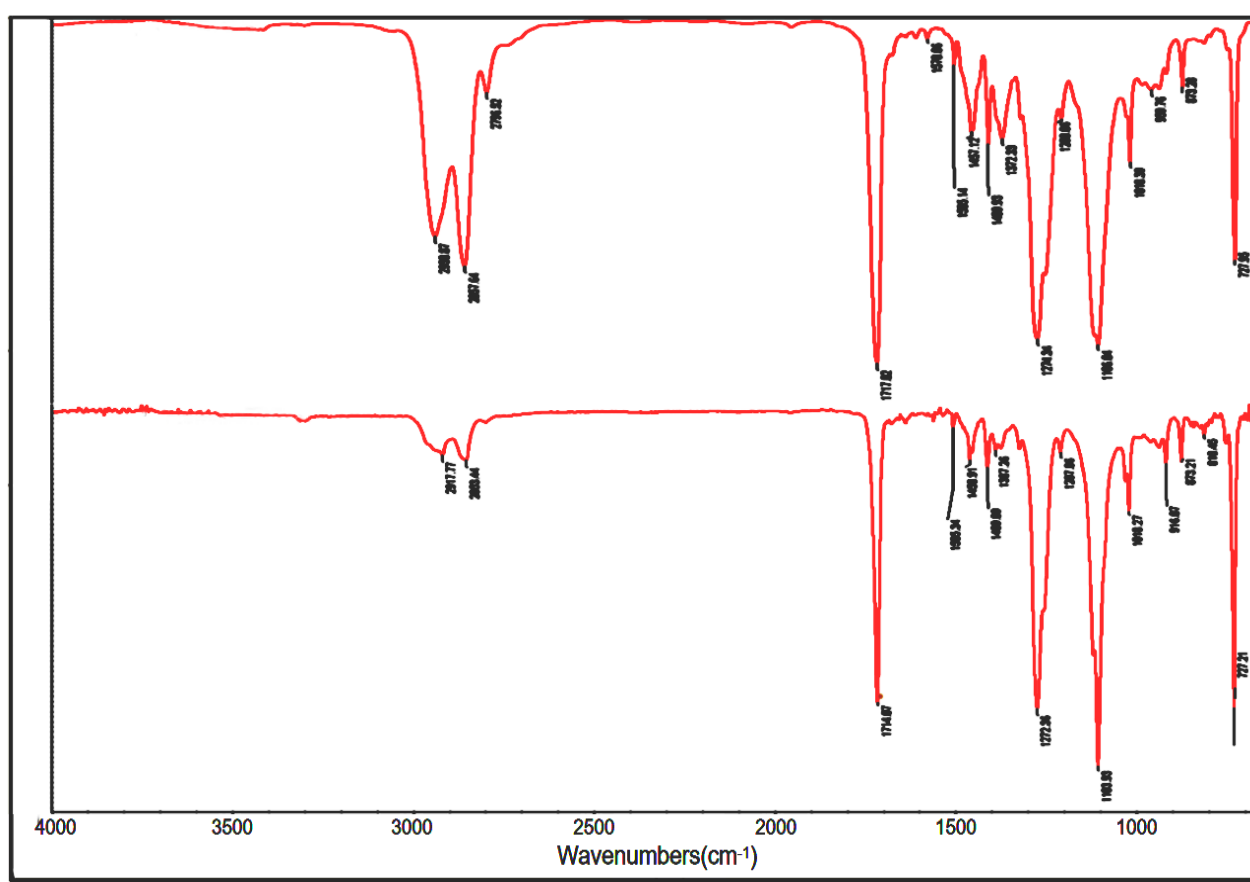
Fig. 2 FTIR of chloroform extract of the failed elastic pad (top) and the normal elastic pad (bottom)

FTIR was used to characterize the failed and normal samples, and the results are shown in Fig. 2. The characteristic absorption peaks of  $2939\text{cm}^{-1}$  and  $2858\text{cm}^{-1}$  correspond to  $-\text{CH}_2$ . The characteristic absorption peak of  $1717\text{cm}^{-1}$  corresponds to  $\text{C}=\text{O}$  of ester. The characteristic absorption peaks of  $1274\text{cm}^{-1}$  and  $1106\text{cm}^{-1}$  attributable to  $\text{C}-\text{O}$ . Compared with the normal pad, the infrared spectrum of the failed pad has no obvious change.

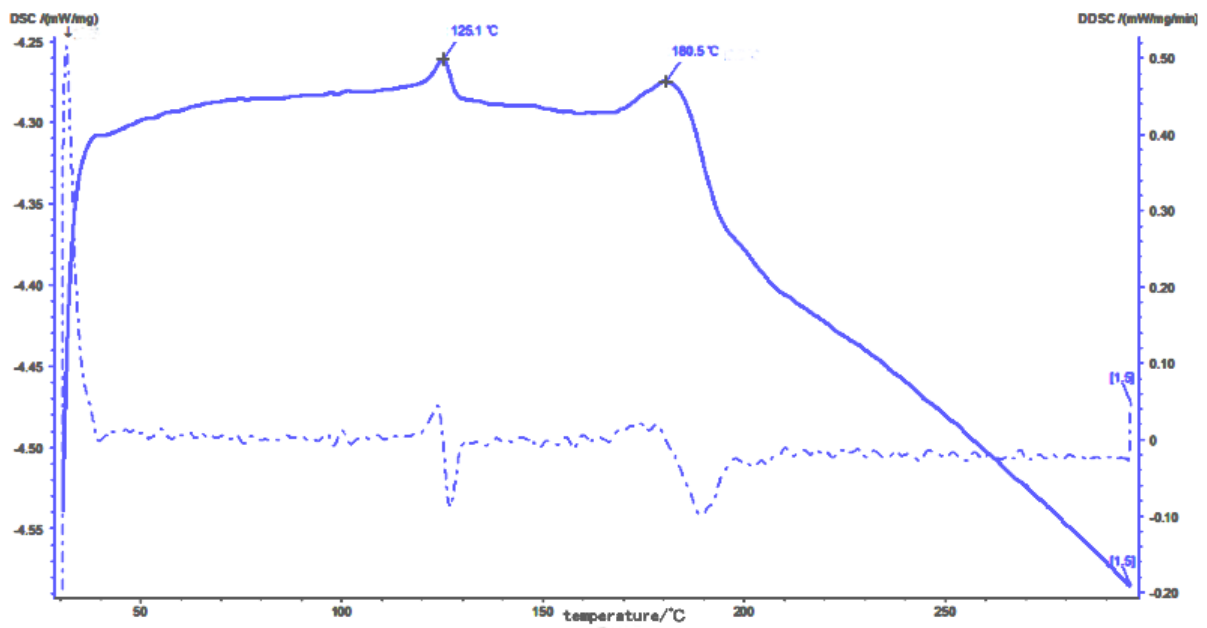
According to GB/T 19466.3-2004/ISO 11357-3: 1999 Plastics—Differential scanning calorimetry (DSC)—Part 3: Determination of temperature and enthalpy of melting and crystallization, DSC tests were performed on the normal pad and the failed pad. The results are shown in Fig. 3, Fig. 4 and Table 4. The results show that the melting point of the failed pad of polyester elastomer (TPEE) was lower than that of the normal pad, indicating that the failed pad was slightly degraded.

Fig. 3 DSC spectrum of failed pad

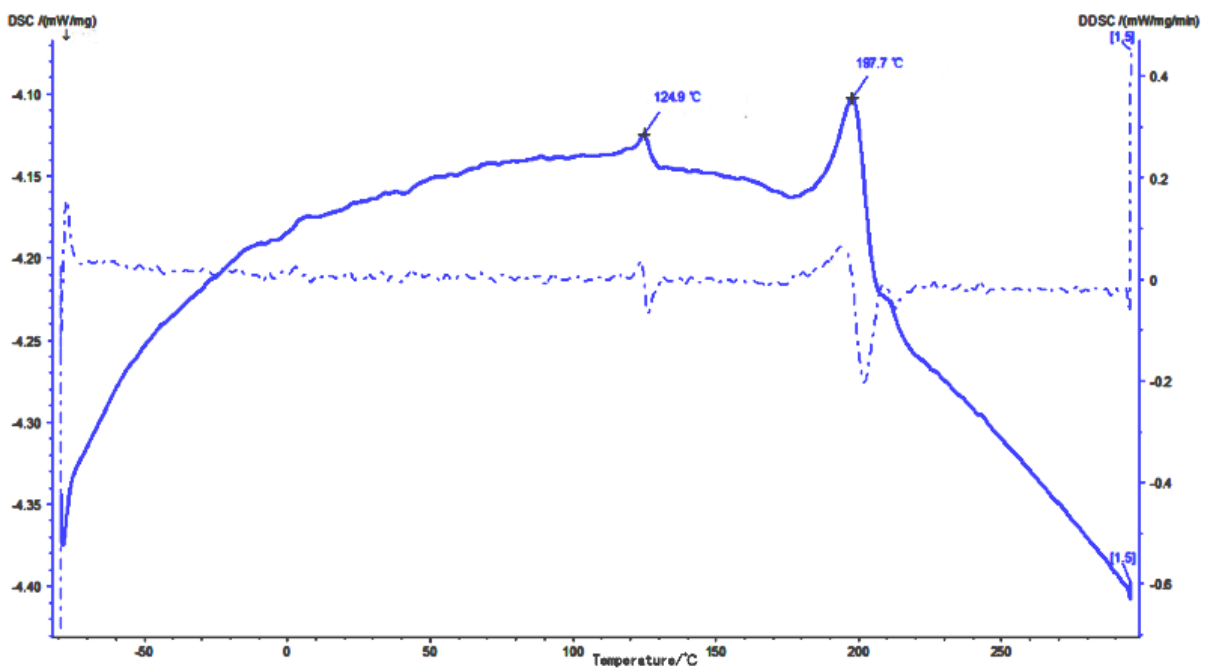
Fig. 4 DSC spectrum of normal pad

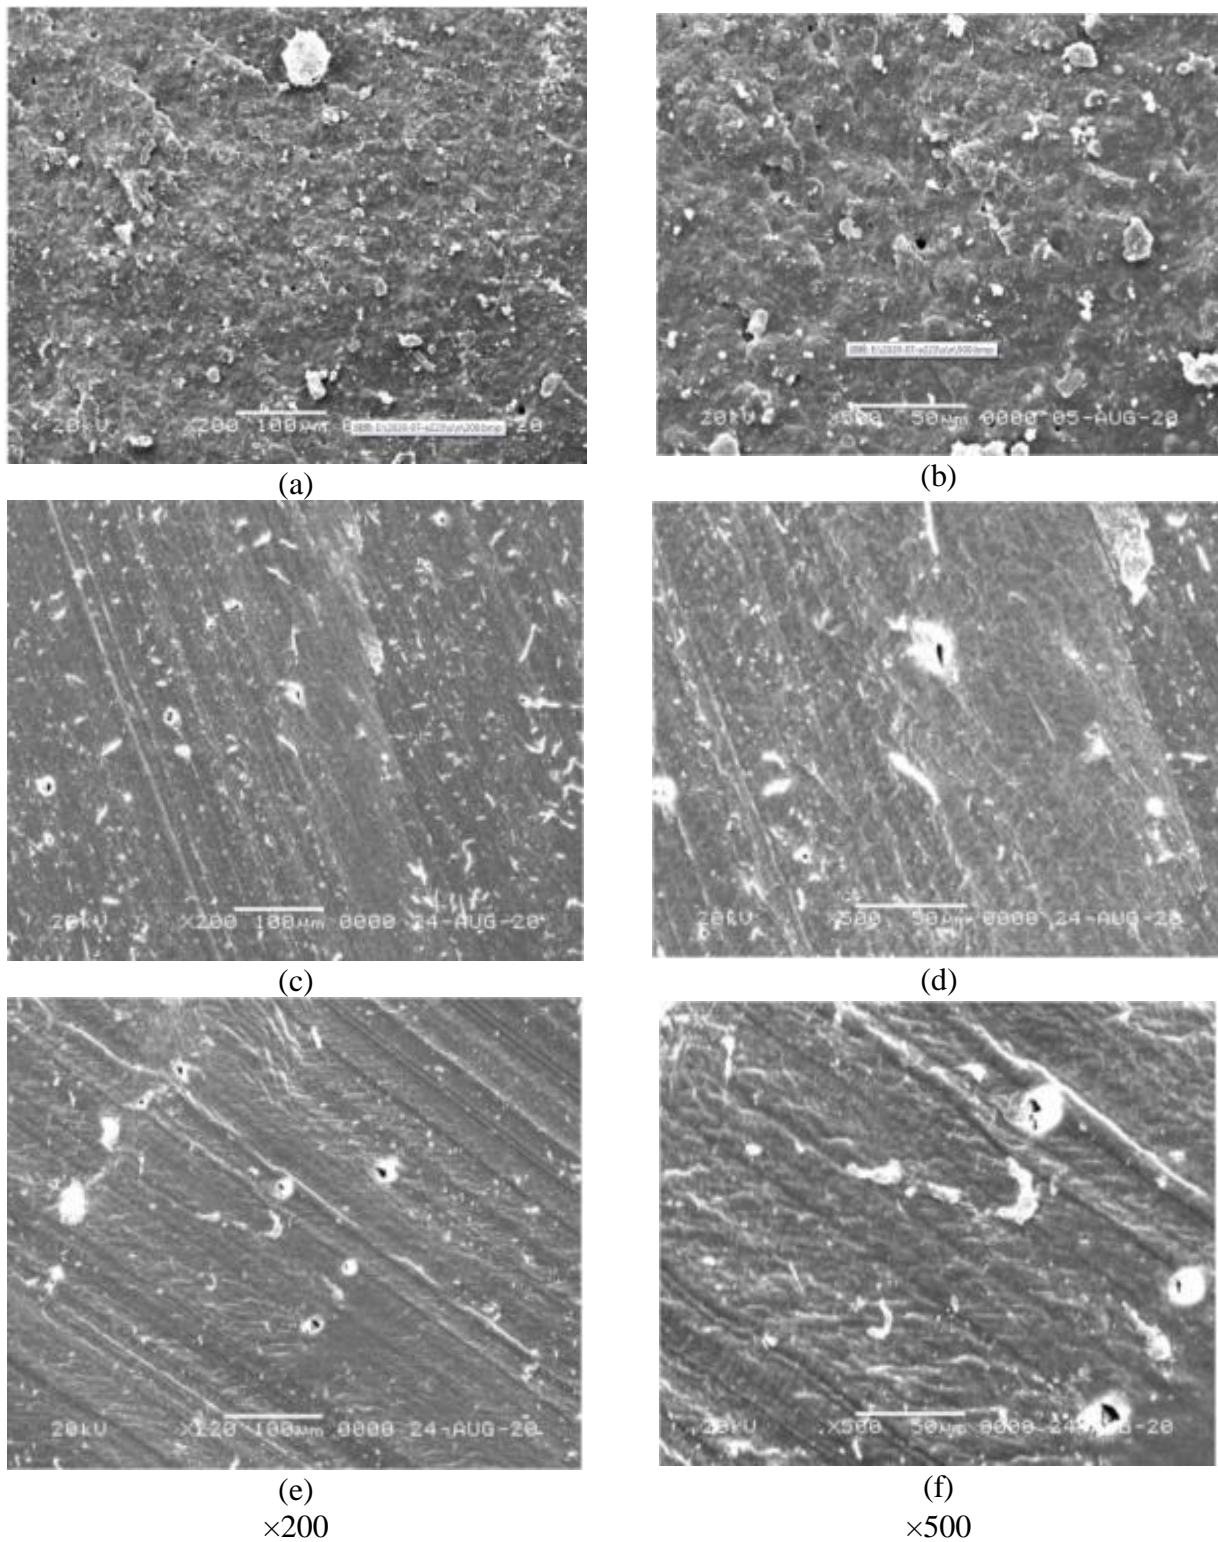
Fig. 6 SEM of the cross section of the failed pad (Fig. a and b at crack; Fig. c and d without cracks) and the normal pad (Fig. e and f)

The SEM pictures show that there are microcracks on the surface of normal and failed pad, indicating that they are all affected by fatigue. [2] The shape of the elastic pad is an asymmetric prism. Therefore, the edge area has the largest deformation, the molecular chain moves the most violently, and the crack originates from the edge. Two similar cracks merge and form a longer crack, accelerating the rupture of the backing plate. The broken section of the failed part is relatively rough, and a large number of polyester aggregates can be seen on the surface. Therefore, when the failed part is subjected to a large

mechanical external force during service, severe friction occurs inside the elastomer and is accompanied by severe squeezing and abrasion. The external load causes the polyester matrix and additives to mix to form aggregates, causing cracks to grow instably. [3] In addition, there are relatively porous holes in the cross section, and microcracks are prone to propagate or break at the positions where there are holes in the material. This situation is more prominent when the sample is undergoing periodic deformation (i.e. fatigue). If the molecular chain is too late to relax when subjected to an external force, the strain lags behind the stress, so that the molecular chain is prone to breakage. When the molecular chain is torn off, micro-cracks will occur, and the micro-cracks will continue to expand under the external force until it breaks.

- (1) There is no obvious difference between the normal pad and the failed pad in the composition analysis, but the melting point of the failed pad is slightly lower than that of the normal pad, and the quantitative analysis of chloroform eluates shows that the failed pad have slightly more small molecules and the failed pad are slightly degraded.
- (2) The cracking nature of the TPEE elastic pad is fatigue cracking, and the failure mode is mainly extrusion abrasion.
- (3) The forming process of the elastic pad should avoid the generation of air bubbles inside the workpiece.

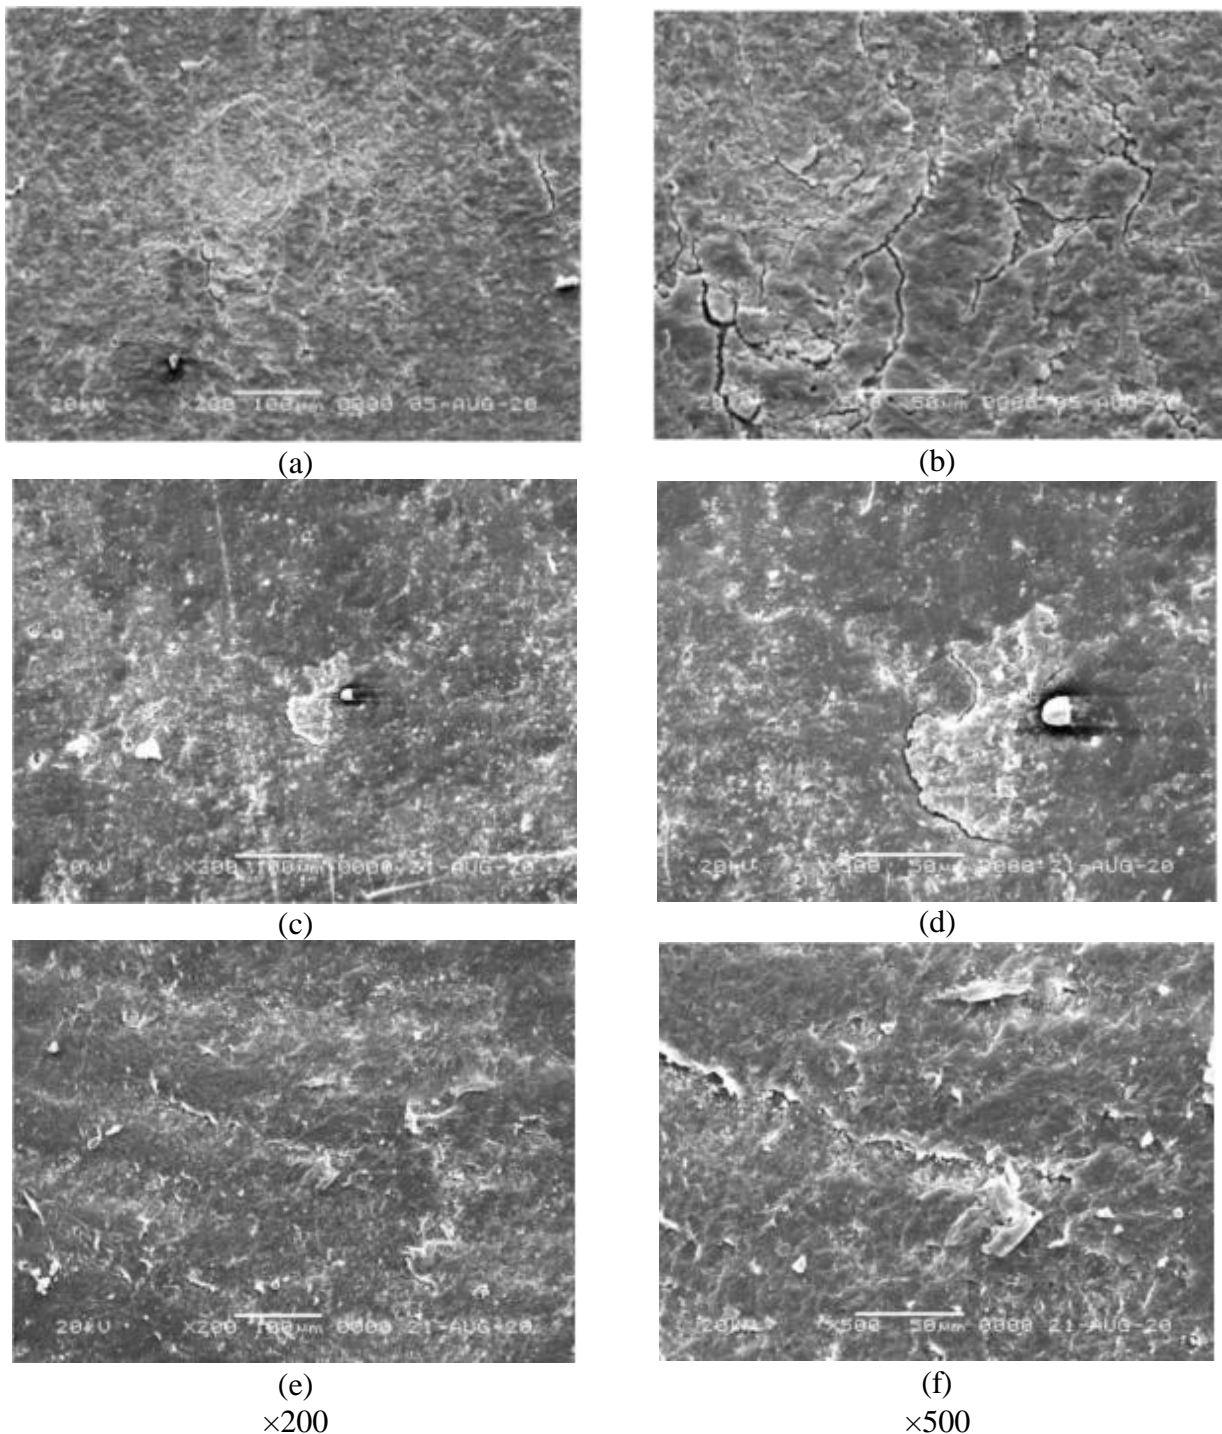
Fig. 7 SEM of the surface of the failed pad (Fig. a and b at crack; Fig. c and d without cracks) and the normal pad (Fig. e and f)
