Detection Methods and Safety Evaluation of Large Aqueduct in Irrigation Districts

Yudi Wang^{1, 2}

¹China Institute of Water Resources and Hydropower Research, China

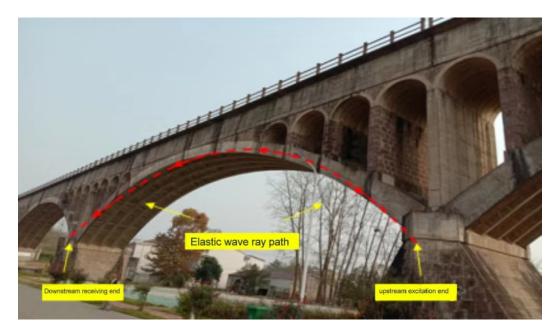
(7) Impact elastic wave method to detect the internal quality of concrete Under the condition of excluding the influence of cracks, the concrete quality of the five aqueduct shells selected for this test can be evaluated as good, but the distribution of concrete quality is uneven, indicating that there may be local durability deterioration problems in the aqueduct shell. The overall quality of the concrete in the arch beam of the aqueduct is slightly lower than that in its shell, but the distribution of the concrete quality in the arch beam is relatively uniform. According to the elastic wave test results and combined with on-site observation, it can be judged that most of the arch beam structures have good overall integrity, and the concrete has not shown serious durability deterioration. However, the right #5 arch beam of the ninth span is significantly different from other arch beams. From the appearance, this arch beam has a local concrete protection layer collapse phenomenon that other arch beams do not have [2]. This may be due to the significantly lower VP3 of the arch beam. The arch inspection points are shown in Figure 1.

Figure 1. Overall Concrete Quality of the Arch Ring Beams Detected by Impact Elastic Wave Testing
