Ultrasonic testing concrete defect verification test

Xinhao Xu

College of Civil Engineering, North China University of Science and Technology, Tangshan City, Hebei Province 063210, China

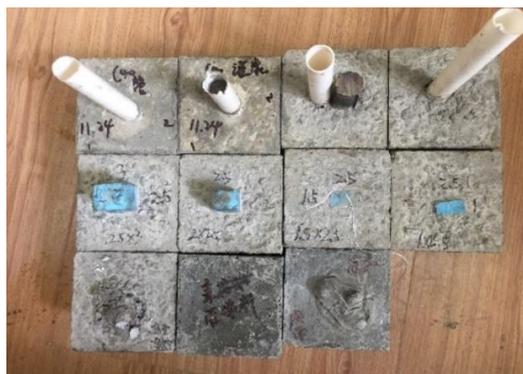
Fig.1 test block detail

For the ultrasonic detection accuracy and the specific conditions of detecting defects, three batches of 11 test pieces of the same size 100*100*100 were produced, the first batch of 4 pieces, the second batch of 4 pieces, and the third batch of 3 pieces [3]. The test block details are shown in Figure 1.

Table 1 Test block batch table

| batch | Test block details | aims |
| First batch | Four pieces of the same batch of concrete respectively inserted into empty pipe, grouting pipe, steel pipe | Verify the effect of steel and pipe on ultrasonic waves |
| Second batch | Four blocks of the same batch of concrete, which are into the four sections of thermal insulation plates with cross-section dimensions of 10*25mm,15*25mm,20*25mm, and 30*25mm | Influence of different insulation board thickness on super-wave |
| Third batch | Two grouting test blocks and one concrete test block in the three test blocks, one of which is placed in the concrete test block and the other is the pure grouting material. The concrete test block is the first batch of the same batch of concrete | Can honeycomb and pockmark be detected in ultrasound |

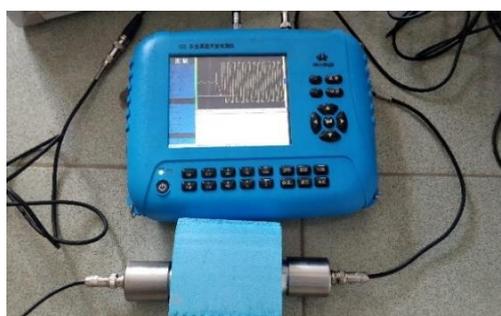
Fig.2 Ultrasonic detector

The equipment used in the experiment is C62 non-metal ultrasonic detector of Shenzhou Huace Co., Ltd, working frequency is 50/60Hz, sampling period is 0.05us-6.4us. The instrument uses two channels and is detected by two low frequency broadband transducers (transmit, receive) with an amplifier bandwidth of 5 Hz to 500 kHz.

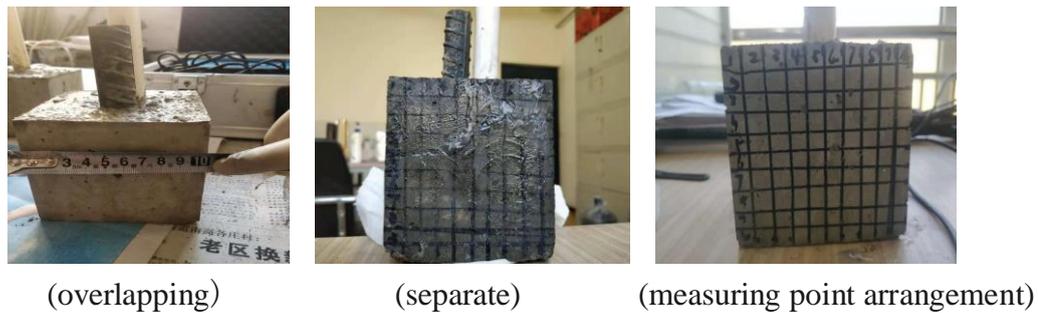
Fig.3 Steel and pipe drawing

The test points and the operation mode are tested according to CECS21-2000"Technical Regulations for Ultrasonic Testing of Concrete Defects"[4]. Since the defect position and depth are set in advance, a separate placement test is performed for each defect area with a measurement pitch of 10 mm at the time of detection. Three sets of sound velocity values and amplitudes were collected twice in the experiment. After the analysis and comparison, it was found that the sound velocity values were more accurate than the amplitudes to detect the existence and location of the defects.

The data in all groups can be seen that the uppermost data value is smaller than the lower group data, because the uppermost detection point is located at the edge of the test block and the ultrasonic pulse wave is seriously attenuated due to the uppermost unevenness.

In the ultrasonic testing, the pipe has a great influence on the detection, and the pipe diameter is 20 mm. For the concrete thickness of this size, the position can be clearly detected by ultrasonic testing. The average value of ultrasonic testing at the steel bar is larger than the mean value of concrete. It is judged that the steel bar has a great influence on the ultrasonic testing, and after comprehensively verifying the concrete, the concrete has a great influence on the ultrasonic.

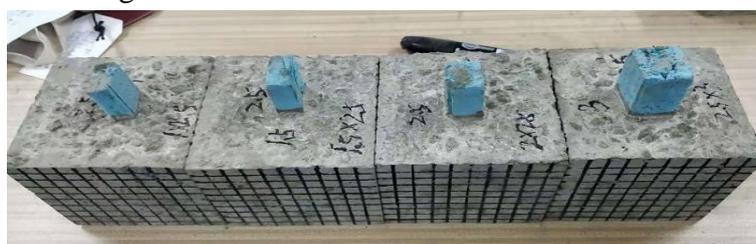
Fig.3 Schematic diagram of different thickness insulation boards

Four concrete test blocks were made in the same batch, and the thermal insulation plates of different sizes of 10*25mm,15*25mm,20*25mm and30*25mm were inserted respectively, and two sets of data were collected for 5 days and 20 days respectively. Compare.

The concrete wave speed ranges from 3,000 to 4,500 m/s, the water is 1,450 m/s, the air is 340m/s, and the polystyrene board (insulation board) is around 800m/s, which is between air and water. The void area was simulated during the test.

This verification test can also prove that the insulation board can be used to simulate internal voids in internal defects and the effect is still ideal.

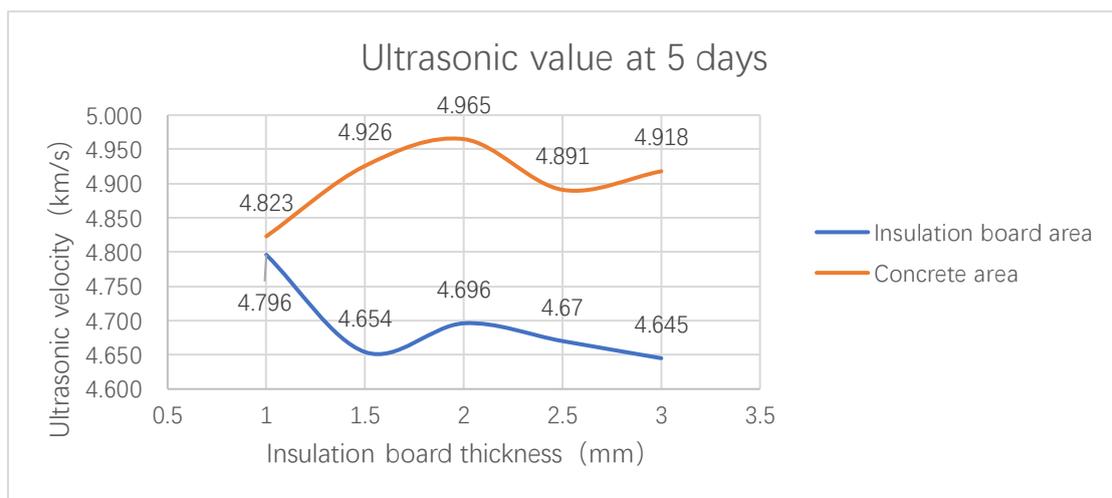
Fig.4 Ultrasonic value of different insulation board thickness on the 5th day of concrete curing

The ultrasonic value of the thermal insulation board area increases with the thickness of the thermal insulation board. The overall trend of the ultrasonic value is downward. It is proved that as the thickness of the thermal insulation board increases, the ultrasonic sound velocity value decreases.

In the horizontal comparison of the same area at different times, the data of 20 days is more stable than the data of 5 days, which proves that with the hydration reaction of concrete, the free water decreases, the overall water content decreases, and the value tends to be stable.

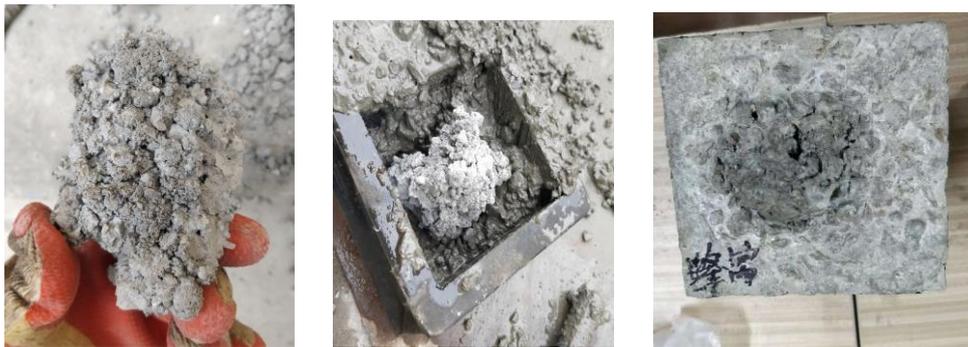
Fig.6 Internal hemp interview block

Such pockmarks cannot be effectively tested in concrete testing. Since there are many influencing factors in concrete, the concrete is replaced by grout and the same operation is performed. The results prove that such defects cannot be detected in actual situations.
