Research on Supporting Safety of Gob Roadway in Coal Lane of Three Soft Strata

Abstract

In this paper, through monitoring, analysis, simulation, test and other research means, in view of the three soft strata coal lane in the goaf roadway different support technology, select the best support scheme and support materials, forming a suitable for Xiao tun coal mine "three soft" formation coal lane along the goaf roadway effective roadway support technology; At the same time, it can also be used for guidance during similar roadway tunneling. Through the industrial experiment of an engineering example, the design of full-anchor grouting support is applied to an engineering example, and the field monitoring results are analyzed. The results show that the support design is safe and feasible.

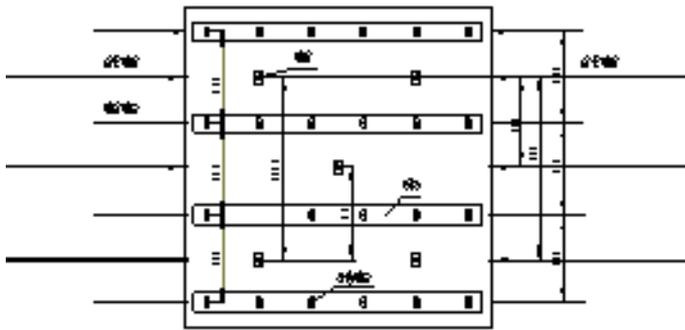
Figure 3-1. Layout plan

The roof bolt is 22mm in diameter and 2400mm in length. Each row has 6 roots and the spacing between rows is 800×800mm. Help of composite grouting anchor rod before body segment Ø 22 mm

in diameter, the backend diameter 25 mm; Length is 3400 mm; Install aperture $\varnothing 32$, built-in hole sealing hole sealing way. Roof resin anchor cable diameter 21.6mm, length 8000mm; Adopt "2-1-2" three-pattern layout. Roof bolt tray for grouting anchor cable 100×100×10mm; Side bolt tray 150×150×10mm; Roof net reinforced spot welding net; 10# wire mesh shall be used on the side; Top net 4900 x 850 mm; Help net 3200 x 850 mm; W220/375 steel belt; Length is 4500 mm; At the same time two aided with steel beam and diamond mesh.

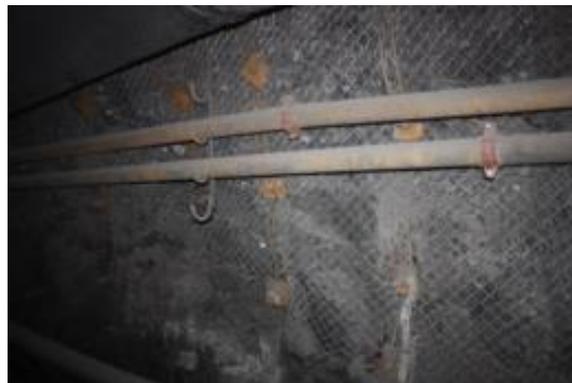
Figure 4-1. The grouting support is neat along the empty side

The net pocket appears along the goaf side of the original branch protector, and the drift moves from the middle to the bottom. The grouting support along the goaf is neat, and there is basically no net in the early grouting section, with a small amount of internal displacement. The side net appears in the original supporting solid coal part; The net of solid coal side of grouting support is basically absent.

Water seepage is common from the middle to the lower part of the primary branch protector along the hollow side. The middle to the bottom of the grouting support is dry, without water seepage. This phenomenon already exists in front and back of the roadway in the test section, which indicates that the grouting cementing material has improved the anchoring performance of the bolt. The current heading head is more than 100m away from the test section, and the ore pressure has appeared.

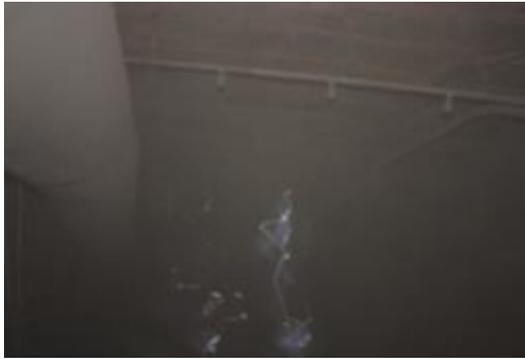
Figure 4-2. Grouting support roadway roof

The steel belt at the top of the original support roadway has been greatly bent, and there are large pockets and bolts moving out locally. The roof of the grouting support is neat with only small bending.

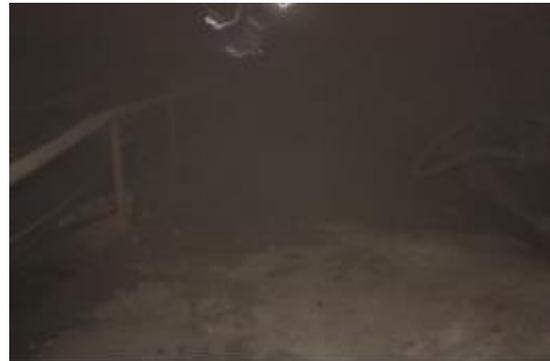
Figure 4-3. Grouting support floor

The roadway height in the test section is 3.0-3.3m. The height of the original supporting roadway is 3.0m. Due to floor heave, the height of part of the goaf roadway is only 2.0m at 100m from the vehicle yard, and the floor of the original supporting roadway is generally wet and soft. There is a lot of soft muddy water on the floor of the original supporting roadway. The bottom plate of grouting support is dry and hard.

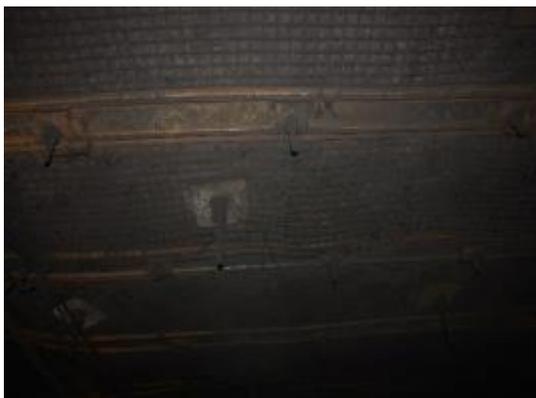
Figure 4-4. Test section integrity roof

Under the influence of dynamic pressure, the height and width of the roadway in the test section were lower than that in the non-test section, and the roadway space was open. The roof of the test section is of good integrity, and the deformation of the shoulder nest is smaller than that of the non-test section. The surrounding rocks of the two sides of the test section are flat and the broken area of the net is much smaller than that of the non-test section. In the test section, the floor heave along the roadway was large in the middle and small near the two sides. The overall floor heave was not found in the test section.

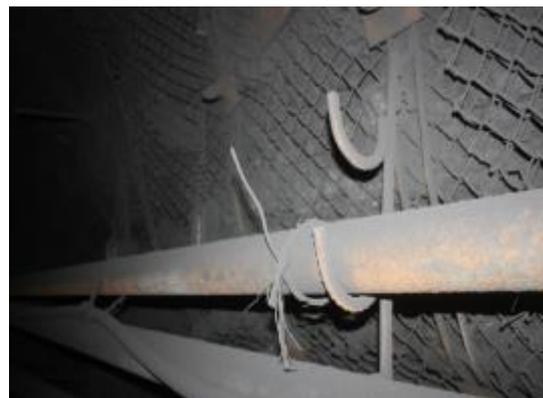
Figure 4-5. The test section is smoothed along the hollow

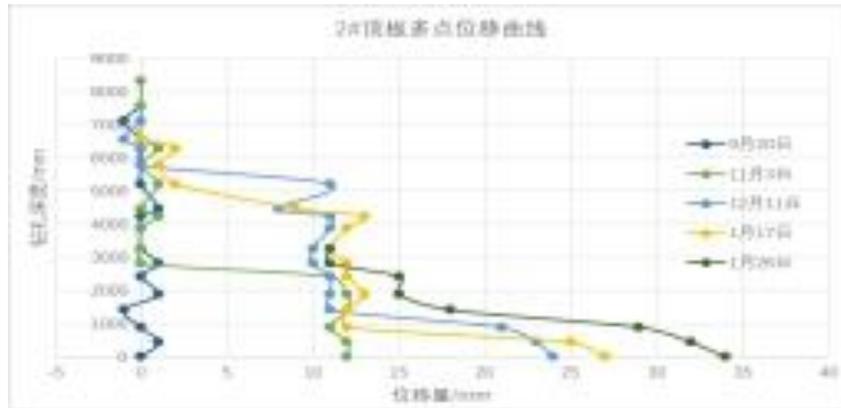
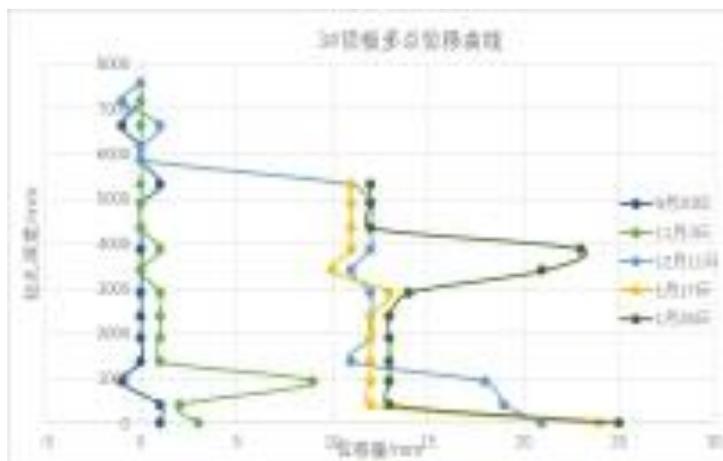
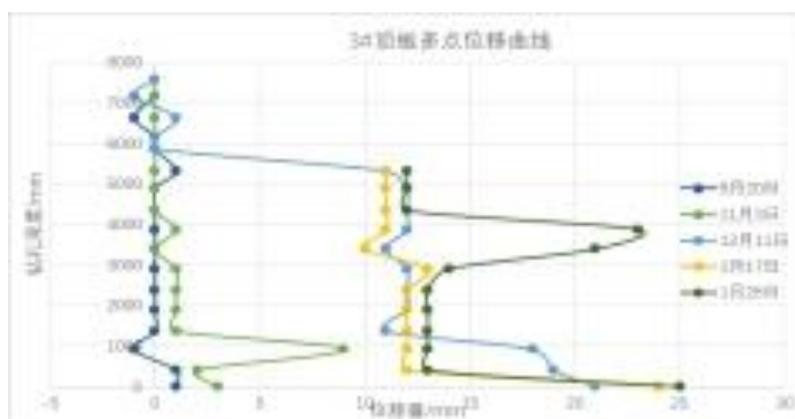
Figure 4-6. Multi-point displacement curve of 1# roof

Figure 4-7. Multi-point displacement curve of 2# roof

Figure 4-8. Multi-point displacement curve of 3# roof

The observed section 2# of the multi-point displacements meter is located in the middle of the test section, while the observed sections 1# and 3# are located at the front and back 20m of the test section respectively. The observation holes in the no.1 and No.2 solid coal sides of the observation sections were damaged in the later stage, and only part of the data were available. The coal body along the goaf has low strength and hole collapse phenomenon. The observed sections 1# and 3# cannot be detected due to borehole deformation and failure.

(1) By comparing the multi-point displacement curves of the top plate of the observed sections 1#, 2# and 3#, the deformation of the top plate is similar: the borehole depth is 1.0m and the deformation is large, up to 10-15mm; The depth of borehole is 3.0m-4.0m, and there is a separation zone of about 10mm. The observation section 1 and 3 are very obvious. The observation section 2 has relatively small amount of two layers, only 4mm, due to the factor of two-side reinforcement. There is a separation zone of about 12mm at the depth of 5.5-6.0m.

(2) Compared with observation sections 1# and 3#, the roof displacement of test section 2# of the main roadway is within the action range of bolt within 1.0m, and the bolt support effect is good; The dissociation occurred only at 5.5-6.0m and the amount of dissociation was relatively small. According to the multi-point displacement curve, the failure of the roof and the integrity of the roof strata can be improved by increasing the strength and stiffness of the two sides.

(3) Time sequence of roof rock failure: In the first stage, the anchor rod plays its role in about 30 days. Firstly, displacement failure occurs in the rock layer near the anchorage scope of the anchor rod; in the second stage, the stratum is separated at 5.5-6.0m in about 60 days, and the anchor cable plays its role; in the third stage, the stratum is separated outside the anchorage area of the anchor rod, and the displacement of the roof increases.

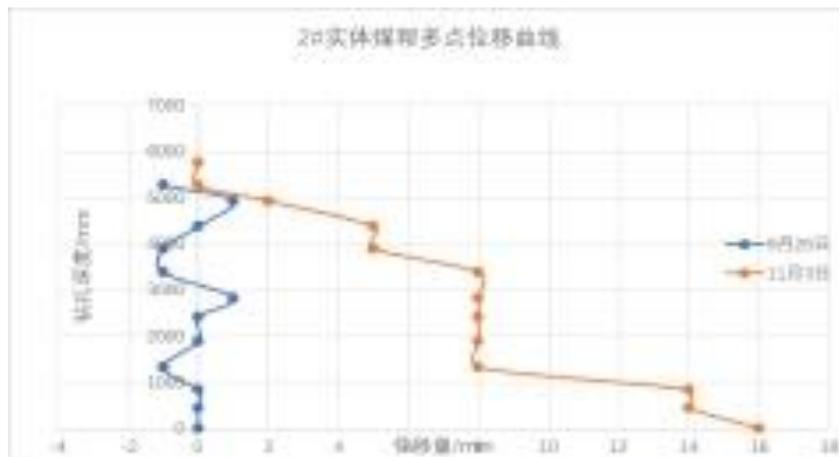
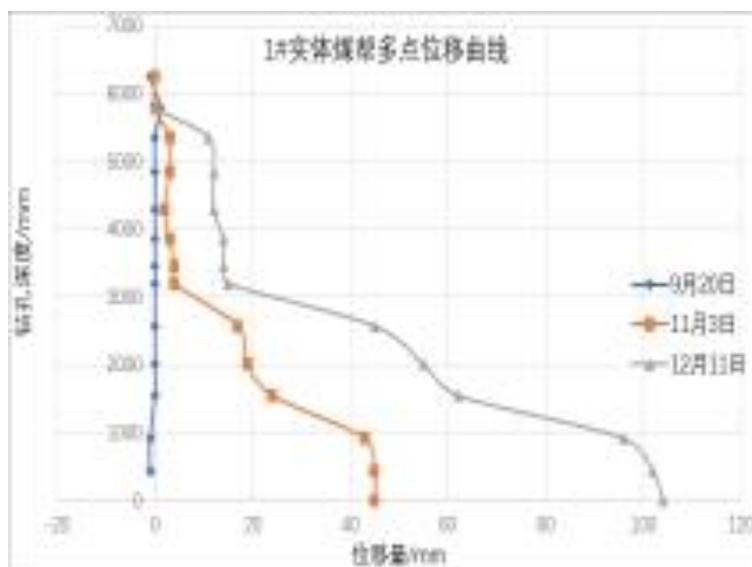
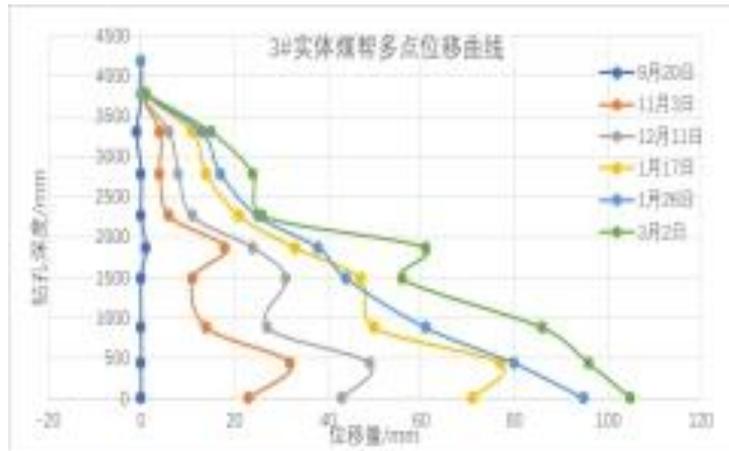
The multi-point displacement curves of the solid coal side on the observation surfaces 1#, 2# and 3# are shown in figure 4-9, 4-10 and 4-11.

Figure 4-9. Multi-point displacement curve of 1# solid plate

Figure 4-10. Multi-point displacement curve of 2# solid plate

Figure 4-11. Multi-point displacement curve of 3# solid plate

(1) Observed multi-point displacement curve of section 3# solid coal side, the displacement of 4 months reaches 100mm, and the whole displacement of surrounding rock is within the range of 4.0m. The goaf roadway is located in the low stress zone, but due to the dynamic pressure of stopping in the previous working face, the coal body is relatively broken, rigid and weak. The goaf roadway was arranged in the surrounding rock with poor lithology, and the solid coal side deformation was large, up to 100mm.

(3) From the analysis of test section 2, the combined bolt length is 3.3m, and the grouting section is 1.0m-3.3m, and the surrounding rock is basically not deformed, indicating that the bolt has a significant anchoring effect, plays a role of integral rock beam, and can reduce the failure of deep coal and rock mass.
